TANK REPLACEMENT CASE STUDY – INSTALLATION OF SECTIONAL GRP TANKS

AQUALOGIC CASE STUDY

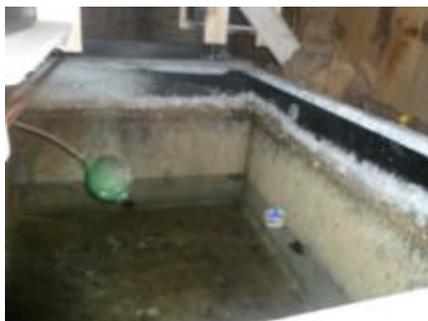
The existing cold water storage tanks suffered from neglect. As well as poor insulation, and high levels of corrosion, the tanks were plumbed in so that stagnation in some was creating a risk of Legionella proliferation. Overhaul was considered, but as the tanks could not be isolated in turn, an epoxy or polymer treatment could not be given sufficient cure time. Refurbishment of untreated tanks with lids, insulation and pipework modifications was uneconomical and replacement the most viable option.
